Manhole Inspection Summary

Manhole # S19W__020MH

Location Address: **2300 washington bd**

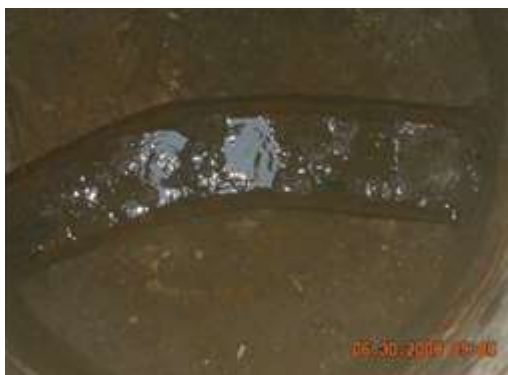
Defect 4

Condition: ☐ Sound ☐ Cracked ☐ Root Intrusion ☐ Deteriorated ☐ Leaks ☒ **Debris**

debris in channel

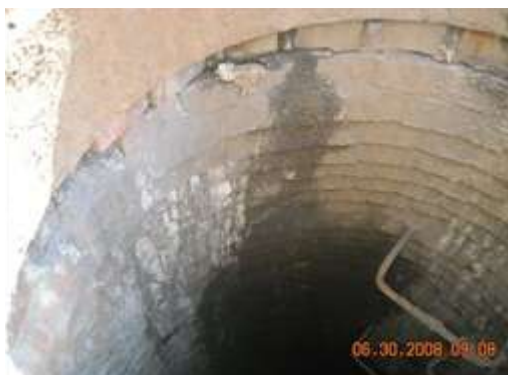
Defect 2

Infiltration: ☐ None ☒ **Joint** ☐ Cracks ☐ Mortar ☐ Roots ☐ Wall

infiltration @ chimney/frame joint

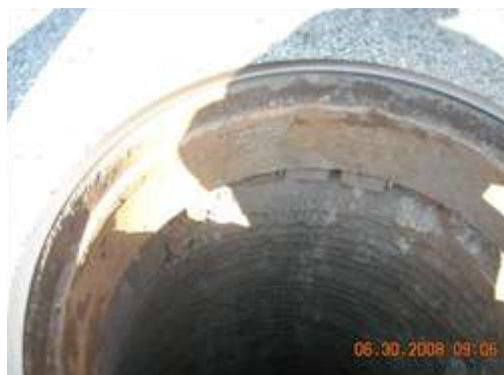
Defect 4

Frame Offset: **0** (in.) Condition: ☐ Sound ☐ Cracked ☒ **Leaks**

Frame leaks-inflow evidence from sheeting

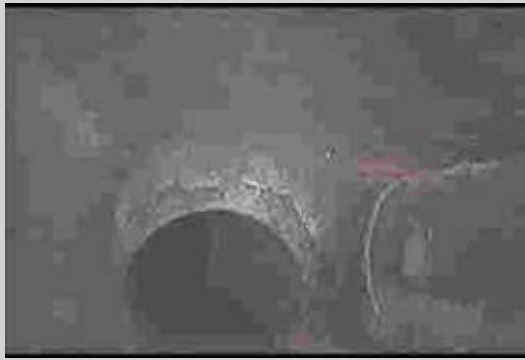
12 O'Clock Outflow

Pipe Height: **8.4** (in.) Rod and Bar (Angled)
Pipe Material: **Clay** ☐ Pipe Lined
Invert Depth: **11.80** (ft.) Flow Characteristics: **Slow**
Deposits: ☒ None ☐ Mud ☐ Sludge ☐ Debris ☐ Grease
Silt Depth: **0** (in.) Deposits Extent:
Infiltration: **None** Pipe Seal Cond: **Sound**

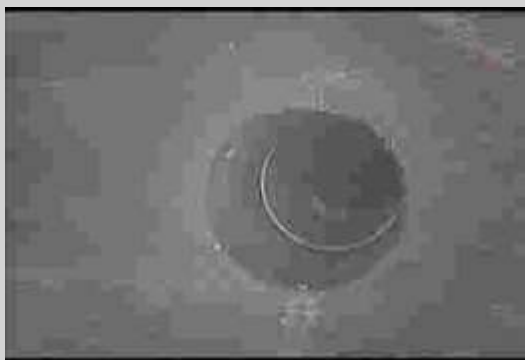
7 O'Clock Inflow

Pipe Height: **8.4** (in.) Rod and Bar (Angled)
Pipe Material: **Clay** ☐ Pipe Lined
Invert Depth: **10.45** (ft.) Flow Characteristics: **Slow**
Deposits: ☒ None ☐ Mud ☐ Sludge ☐ Debris ☐ Grease
Silt Depth: **0** (in.) Deposits Extent:
Infiltration: **None** Pipe Seal Cond: **Sound**

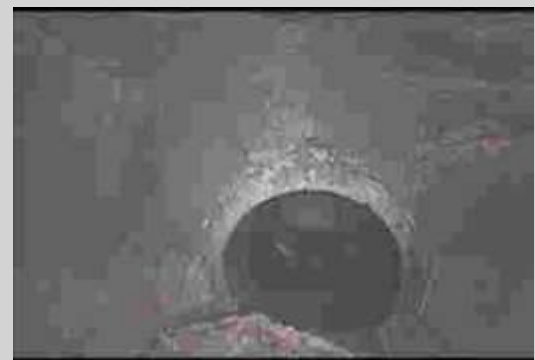
Drop In @ 7 O'Clock

Drop: **Outside** Rod and Bar
Angled: **Yes** Reading: **10.70** (ft.)
Inv Depth: **11.70** (ft.)
Drop Condition: **Open**
